Annual Report----- July 1, 2007 thru June 30, 2008

## **Cultural Resources Management Projects Performed at the Pōhakuloa Training Area, Island of Hawai'i, Hawai'i.**

**U.S. Army Garrison, Hawai'i**

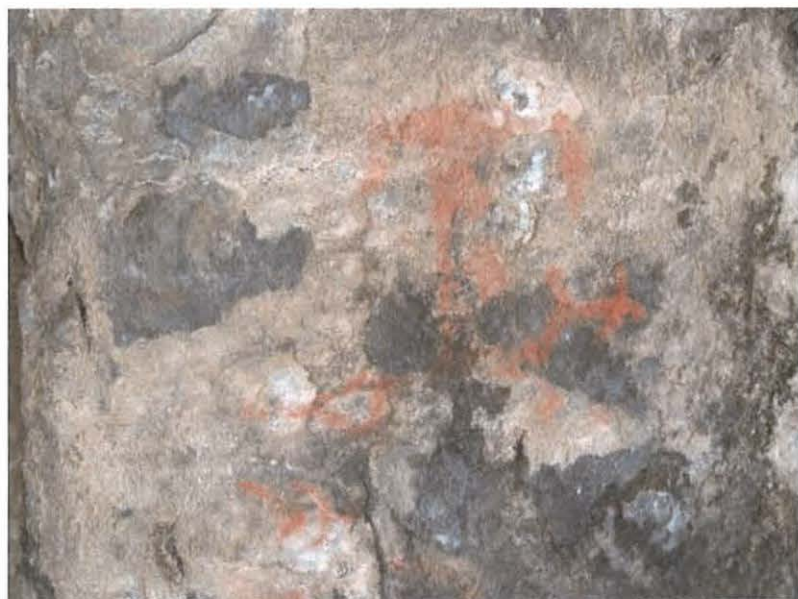
Plate 2. Pictograph panel at Site 23450

5. A rock shelter is present on the northern side of the sink, designated Feature 1 by GANDA. The southern side of the shelter is covered with grass (Plate 1). The interior appears to be relatively undisturbed, with new plants sprouting in this part of the rock shelter. Bird bone and an opihi shell were identified on the floor of the shelter. Goat tracks and scat were present on the soil surface of the rock shelter. The pictographs on the shelter wall appear to be in good condition (Plates 2-6). The photos were taken from the western end of the pictograph panel to the eastern end.

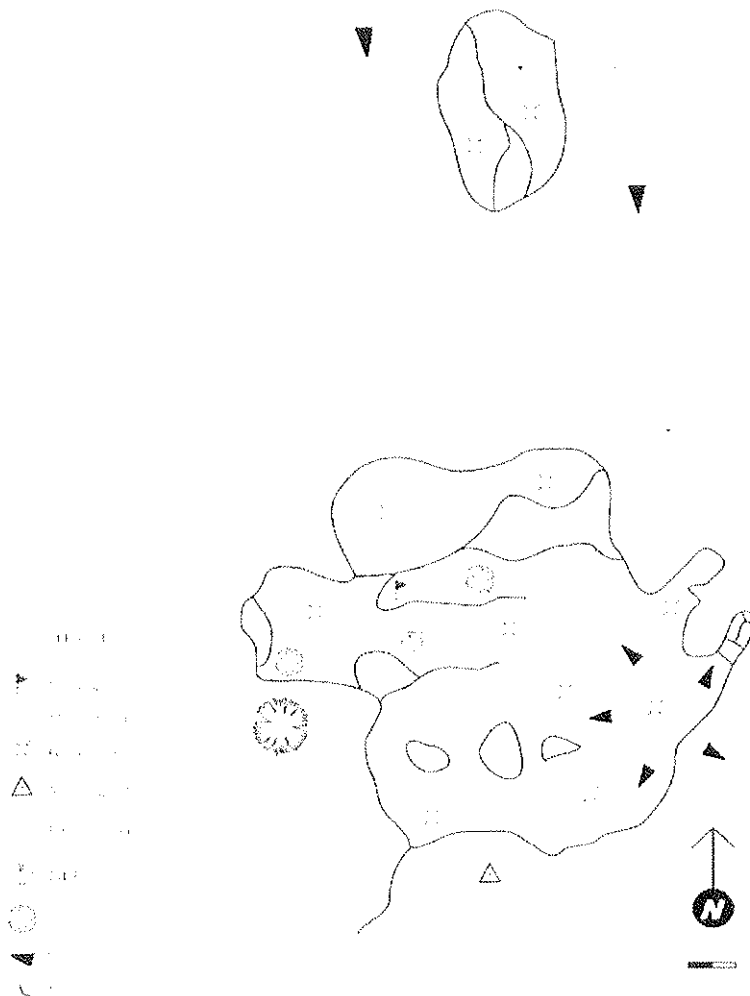
Figure 4. Site 21671 Feature 11

west side of the site at about 12 m north of the mapping datum. A glassy lobe was observed that appeared to exhibit the result of a hit from ammunition. This lobe overlay a non-glassy basaltic flow. An apparent point of impact at the edge of the break on the glassy lobe was blueish black with a more glassy appearance than the surrounding rock, as if it had been heated and cooled very quickly. Feature 11 appeared to be in good condition, although the area has clearly been used. Ungulate scat was observed across the feature, a tobacco canister and a used key can opener were found, as well as the PVC pipe and metal bar. Shrapnel, shell casings and garbage from MRE packs were also noted across the feature.

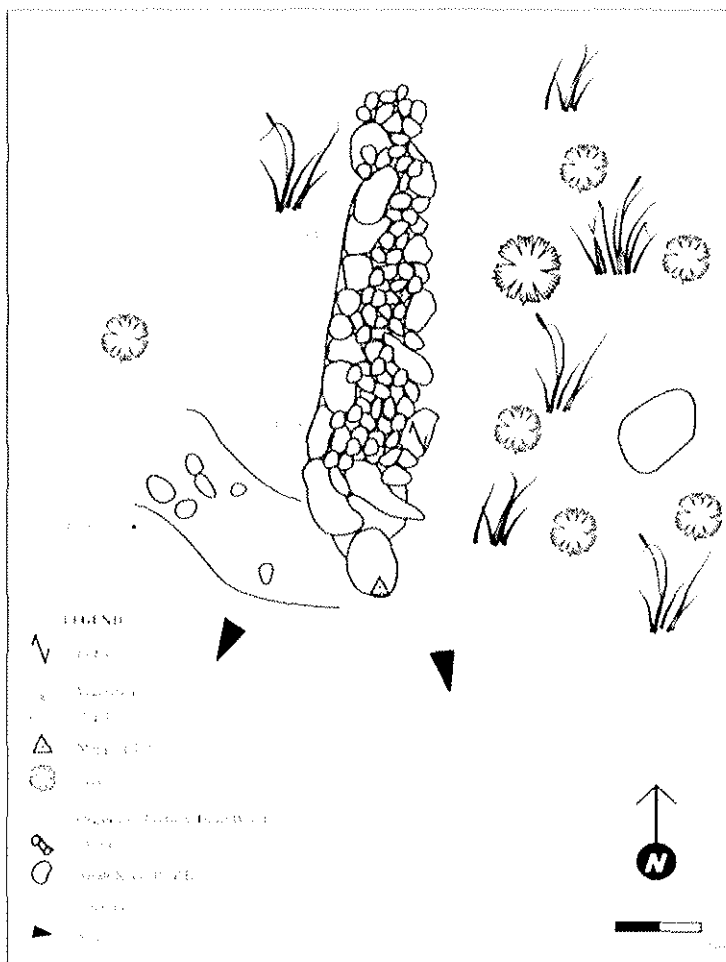
Figure 6. Site 14638 Feature 2 plan view

Feature 2 is a wall (also referred to as Structure 2 in Bayman et al 2001) at the north and eastern edge of the site, on a higher elevation than and to the northeast of Feature 1. There are level areas on both sides of the wall. The wall seems to be in good condition. Basalt flakes were noted on the surface to the northwest of the wall, as was a rusted tin can. Dense goat scat and vegetation debris covered the surface on the southwest side of the wall, and possible dog feces were noted on the surface here. This area is covered with a small naio thicket that makes surface inspection challenging. A long piece of glassy basalt with a triangular cross-section was found in a crevice of the wall. The feature was photographed, a GPS point taken and a plan map was made of the feature (see Figure 6).

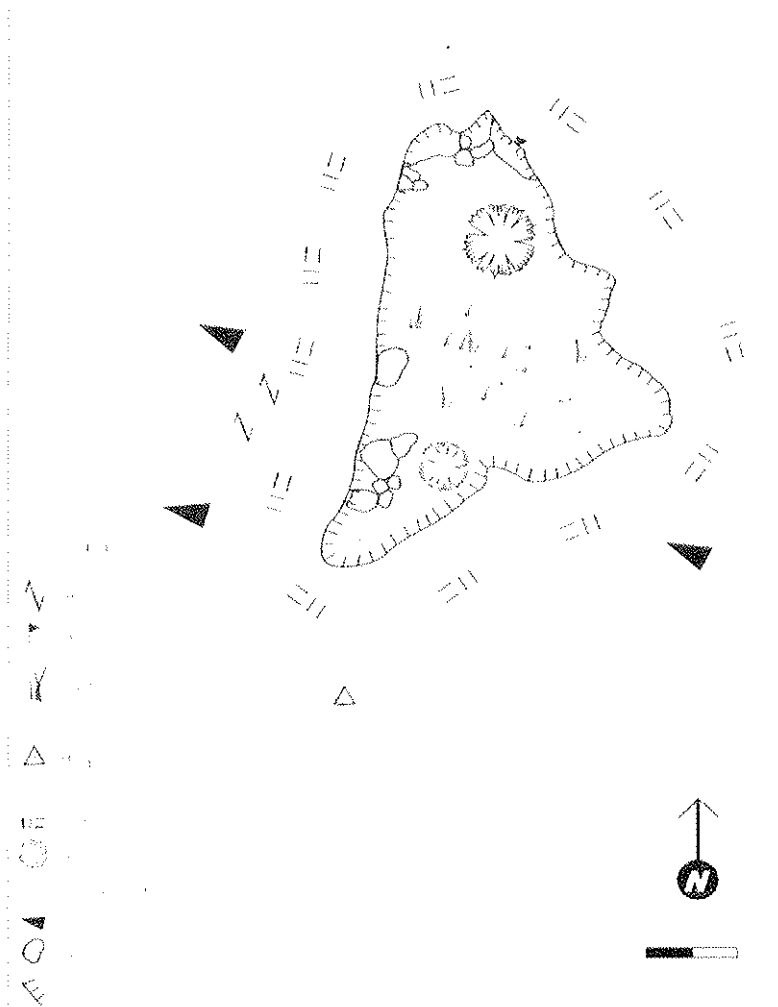
Figure 10. Site 14638 Feature 8 Plan map

Feature 8 is a small *kīpuka* with overhangs and was identified by PTA Cultural Resources staff. Approximately three naio trees are present in the *kīpuka*, the floor of which has soil deposits. No artifacts were observed within the *kīpuka*, though surface visibility was poor. A broken bird stone and an oblong rock were noted on the surface of the pāhoehoe to the west of the *kīpuka*. The feature appears to be in good condition, and was mapped (see Figure 10), photographed, and a GPS point taken.

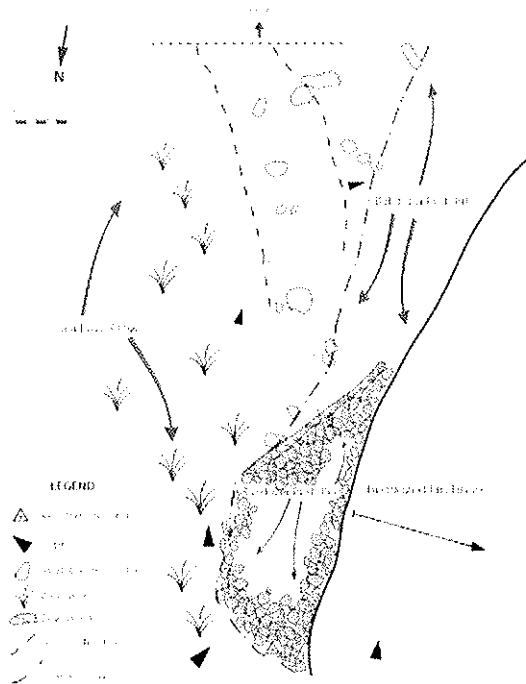
The trail is generally in good condition where it has not been crossed by bulldozer activity. The construction incorporated basalt boulders and other elements of the landscape around the trail. In some places there is curbing along the sides, in others this is absent. Some sections are densely paved, while others have more sparse paving. The landscape around the trail in this northern section consists primarily of undulating 'a'ā and pāhoehoe lava. In places where the trail crosses a low spot, a causeway-like structure is built up.

Figure 10. 19528 Trail, mapping segment AA-1, at the northern terminus of the trail with areas of dozer impact indicated.

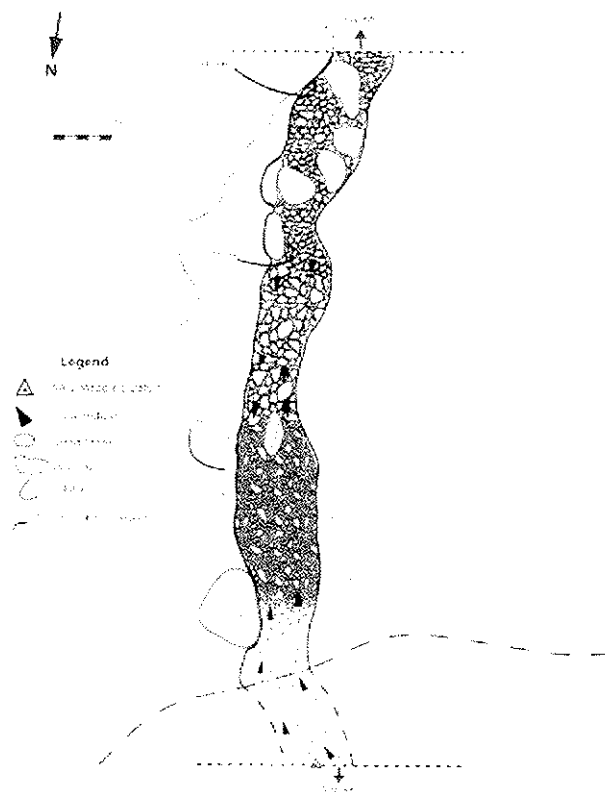
Figure 11. 19528 Trail, mapping segment AA-2, near the northern terminus of the trail with areas of dozer impact indicated.

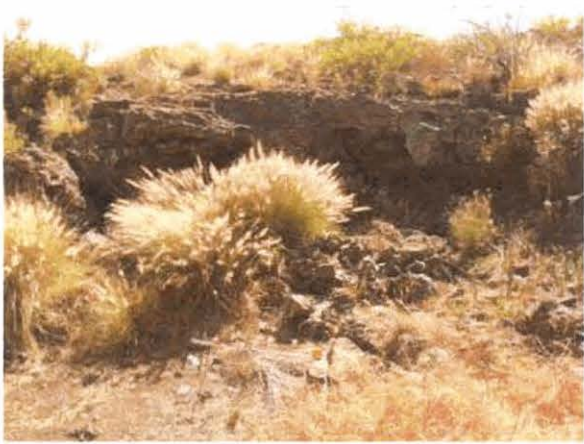
Plate 48. Site 23450 Feature 1

The primary recommendation for this quarter is to dedicate more time to this activity. There do not appear to be any imminent threats to the sites visited during this quarter, with the possible exception of goats at 23450.

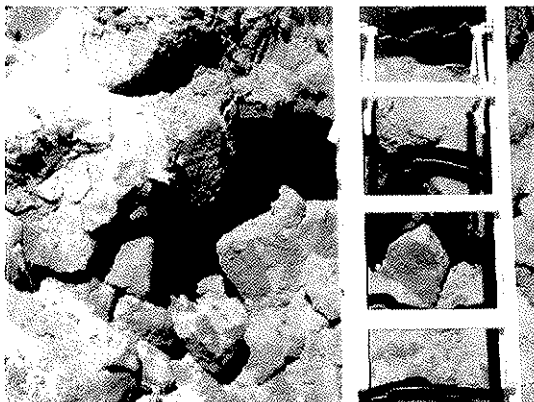
Plate 66. View of the small void found in the western wall of the Septic Tank #01 excavation.

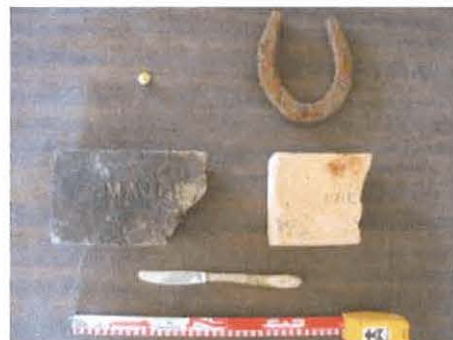
Five historic artifacts were located during the IWS #12 monitoring project (Plate 83). All items were found at the IWS #12a portion of the project. The original depths of the items are unknown, since all were located in back dirt piles. Table 1 lists the items.

Plate 83. The collection of artifacts found during monitoring of IWS #12. The scale is 0.40m long.

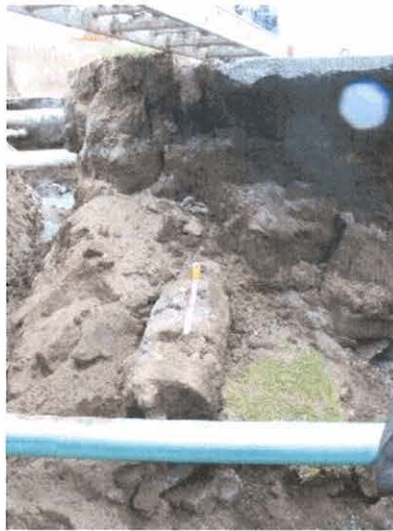
Plate 87. This is a view of the concrete pipe base found during excavation of Septic Tank #14.  
The scale is 0.50m long. Note the mold of the feature in the wall below the horizontal ladder.

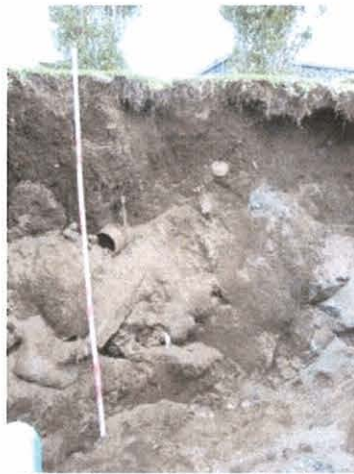
Approximately 2m to the north, a concentration (IWS #14 – Concentration #01) of rusted roofing material, planed lumber, rusted 6” O.D. Cast Iron pipe, a piece of black cotton, and a white plastic grocery bag were also noted (Plate 88). This latter grouping is thought to represent materials from the replacement of the original roof on Cesspool #14 with the current cement cover. The black cotton and plastic grocery sack appear to be more recent.

Plate 88. IWS #14 – Concentration #01 in the north wall of Septic Tank #14 excavation.  
The view is looking to 0° (north) and the scale is ca. 2.0 long.

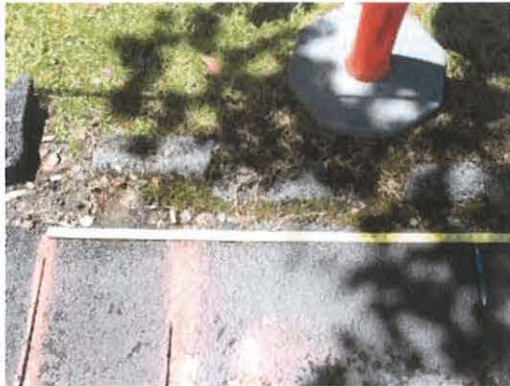
since the contractor also had to remove and replace the basalt curbing stones at IWS #11, #12, #13, #14, #18, and #20. The basalt curbing in the original alignments had often collapsed, and the replacement activities restored them to nearly the original state. The basalt curbs were apparently built by the CCC (Civilian Conservation Corps) (Tomonari-Tuggle & Slocumb 2000:III-45) in the 1930s.

Plate 90. This is a view of the eastern end of the basalt curbing before removal.  
The pencil marks 1.0m on the vertical scale.

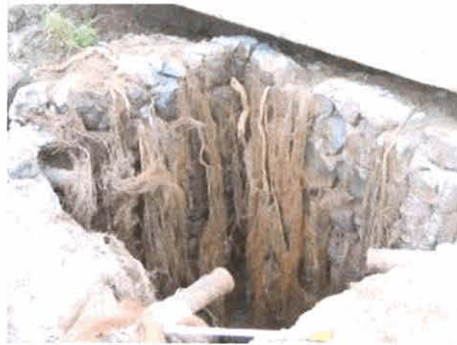
**Findings** – As found at IWS #04, #12, and #13, a masonry wall was constructed on top of the pāhoehoe lava in which Cesspool #18 was excavated (Plate 92, Figures 48 & 49). This feature consisted of a stacked basalt rock enclosure forming a square wall. The lower enclosure (IWS #18 – Feature #01) walls are single course stacked 3-10 courses high with cement grouting between the stones. All four of the walls rested on solid pāhoehoe and four cast iron pipes were projecting through the walls. IWS#18 – Feature #01 measured ca. 2.3m<sup>2</sup> and 1.8m high. The enclosure appears to have functioned as support for the concrete and stacked rock cover that rested atop of the structure and it also provided support for the incoming septic lines that emptied into the old cesspool. The feature was removed after recordation since VAP #18 was scheduled for placement in that location.

Plate 92. IWS #18 – Feature #01 at Cesspool #18.

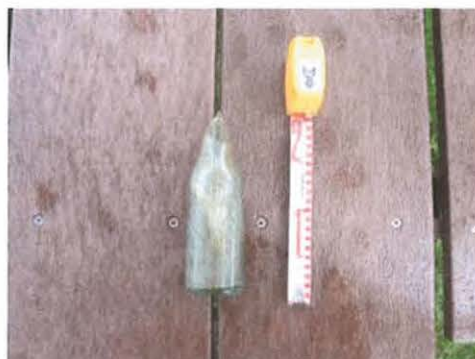
IWS #18 – Artifact #01 is a partial historic bottle found under the Northwest corner of IWS #18 – Feature #02 during the removal. This bottle (Plate 94) is a mostly complete green glass bottle with “Property of Hilo Soda Works Hilo, Hawaii” in raised (embossed) letters on the front. There is a large “HS” on the base and it measures ca. 0.20m by 0.08m diameter. The finish is broken off.

Plate 94. IWS #18 – Artifact #01, a partial Hilo Soda Works beverage bottle.

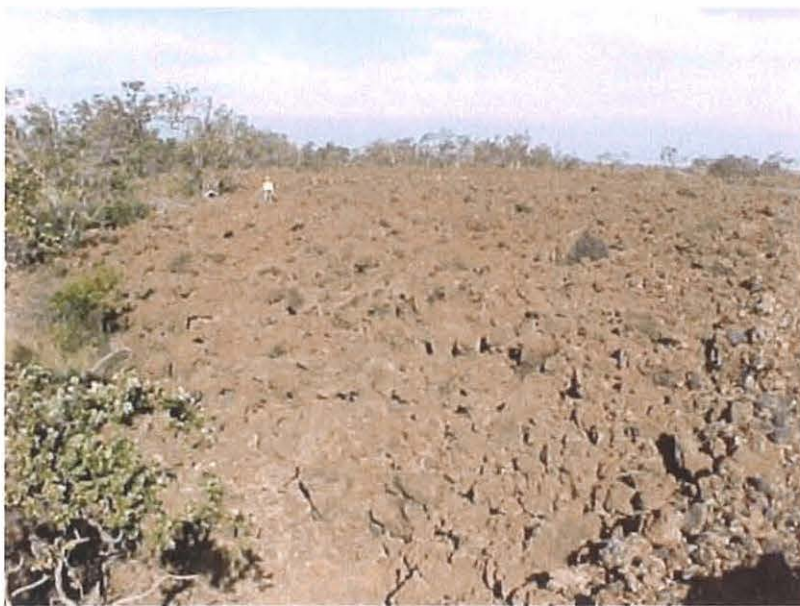
Plate 102. This view is looking west to the proposed Turn-Around #02.  
Note the bulldozer push marking the end of the proposed area.
