Annual Report----- July 1, 2007 thru June 30, 2008

## **Cultural Resources Management Projects Performed at the Pōhakuloa Training Area, Island of Hawai'i, Hawai'i.**

**U.S. Army Garrison, Hawai'i**

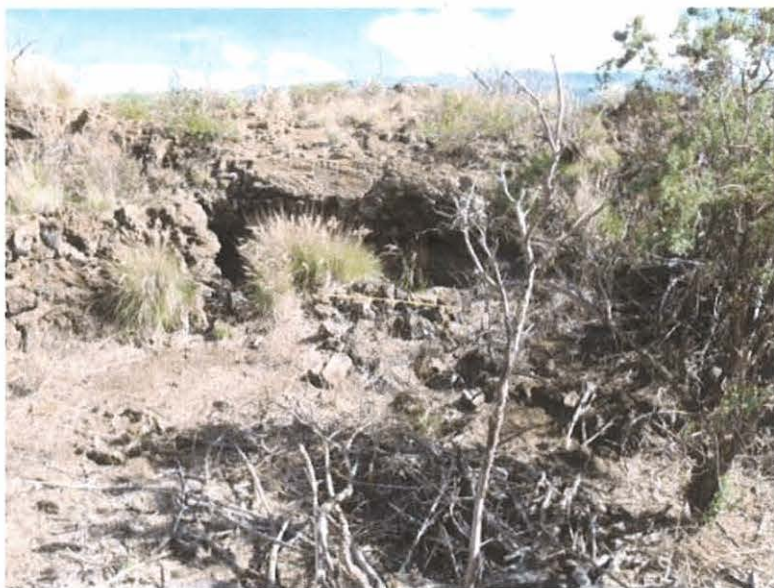
Plate 1. Site 23450 to the north

5. A rock shelter is present on the northern side of the sink, designated Feature 1 by GANDA. The southern side of the shelter is covered with grass (Plate 1). The interior appears to be relatively undisturbed, with new plants sprouting in this part of the rock shelter. Bird bone and an opihi shell were identified on the floor of the shelter. Goat tracks and scat were present on the soil surface of the rock shelter. The pictographs on the shelter wall appear to be in good condition (Plates 2-6). The photos were taken from the western end of the pictograph panel to the eastern end.

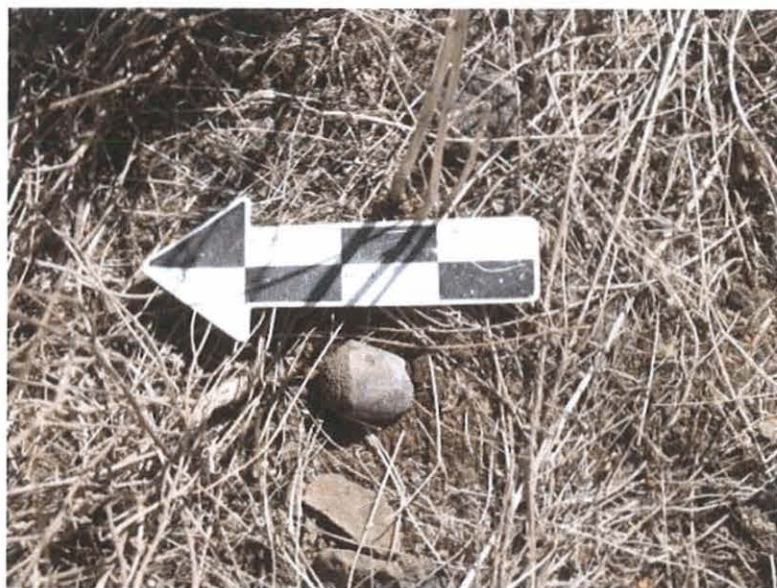
6. GANDA designated the base of the sink, with scattered stone artifacts, as Feature 5. Basalt flakes and a portion of a basalt stalactite artifact were located on the floor of the sink (Plates 7 and 8).

Plate 7. Site 23450 Basalt Stalactite Artifact Fragment.

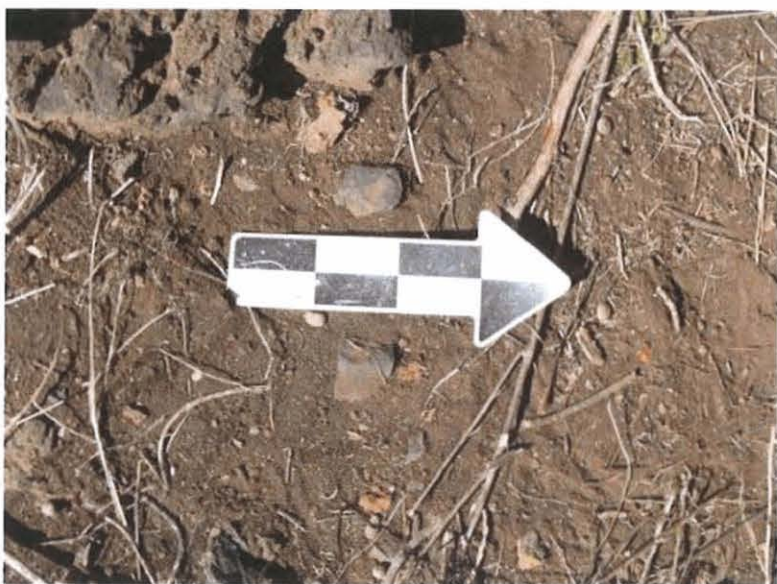
Plate 8. Site 23450 Basalt Flakes.

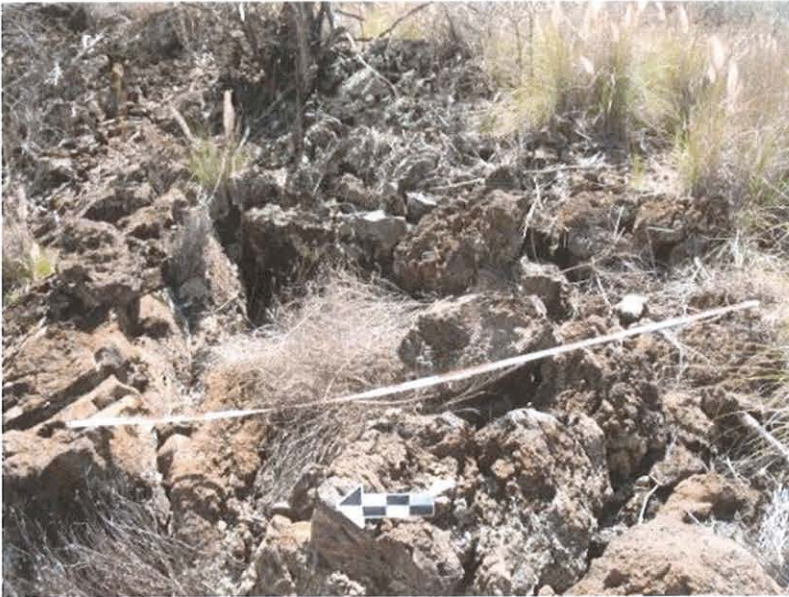
9. At db point 4, a squarish pit was observed on a ridge in an undulating landscape (Plate 9). Fine-grained basalt was present in the vicinity, but none of it was clearly worked for tool production. No cultural material was present in the pit, though a void was evident on the northeast side under a lava shelf. To the southwest of this feature along the side of the ridge was a rectangular area

Plate 9. DB4 pit

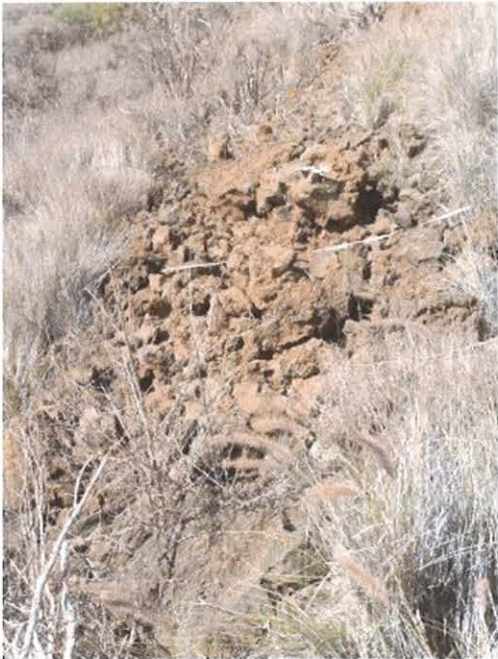
- that appeared to be terraced (Plate 10). Several additional areas along this ridge and an adjoining ridge also appeared to have been modified.
10. The site designated "15" by GANDA, consisting of 3 mounds, was located. The first mound encountered is a low linear mound with no evidence of disturbance (Plate 11). It is located in a low spot in the landscape. To the north/northeast of the first mound is a second one, very tall, located at a higher elevation on an eroding tumulus (Plate 12). The surface around is rubbly. An arrow tip was found embedded in a dead tree trunk. A mammal skeleton was found to the west of this feature. Ammunition shells were sparsely distributed on the ground surface in the area. The mound is in good condition and does not appear to be disturbed. A cobble exhibiting indications of modification was also found (Plate 13). At the northern end of the eroding tumulus was a third mound (Plate 14), lower than the middle mound at the southern end of the tumulus but larger overall than the southernmost mound. The base area was similar in size to the mound at the southern end of the tumulus. A GANDA site tag was found in this mound identifying it as site T-15 Fe. A.

Plate 10. Terrace southwest of pit

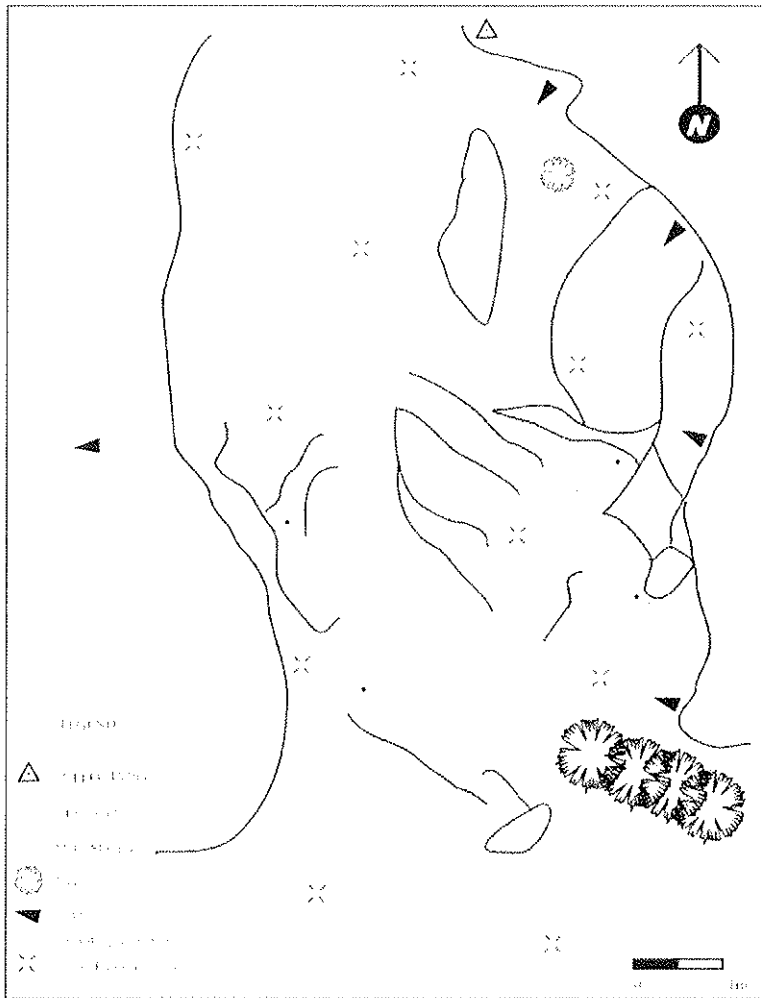
Figure 5. Site 21671 Feature 12

Feature 12 measured 11 m at 0° by 10 m at 90°. The GANDA site tag was relocated, as was a very weathered site tag that may have been placed by the Ogden crew (Williams 2002). Apparent flakes were found beyond the extent indicated by the Roberts et. al 2004 data. Large 'ohi'a trees were present at the feature, as were small naio, pukiawe, a'ali'i, grass, lichen and moss. Three areas were noted where rock appears to have been removed from the pāhoehoe. Flakes of varying quality were found across the feature. The extent of the feature was based on the distribution of the flakes. The feature basically appears to be in good condition. Goat scat was present across the feature, and 3 pieces of shrapnel were found on the feature.

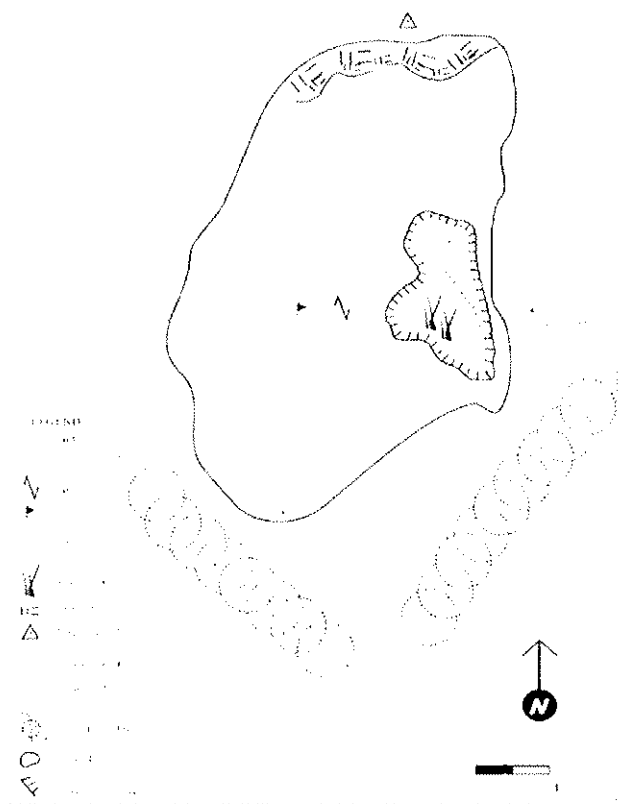
Figure 7. Site 14638 Feature 3 plan view.

Feature 3 is a small lava tube blister immediately west of Feature 1 (Figure 7). Opihi shells and lithics were noted by Bayman et al 2001. Basalt flakes were present on top of the blister, some of which were quite small. The blister floor is largely covered with soil, approximately 75% of the area. Plants, including a stinging plant, are growing across most of the area, including in shaded areas. Basalt flakes were observed under the northern overhang area; the grass matting across the exposed portion makes surface visibility negligible. A can and a remnant of cloth-based tape were present in the western side near some scattered basalt flakes. Opihi shells and a bird breast bone were present on the northern side of the blister, and other sea bird bones were present. Bird bone was also present to the northwest. An oblong stone with one end broken, potentially a bird stone or pestle, was noted on the western side of the blister. Charcoal was present on the southwestern side. Volcanic glass nodules were present on the edge

of the surface on the eastern side, as were some small flakes. Goat scat was noted on the surface of the lava. The feature appears to be in good condition with very little disturbance. The blister was mapped during this monitoring project as no plan map of the feature had previously been made. GPS point was taken and the feature was photographed.

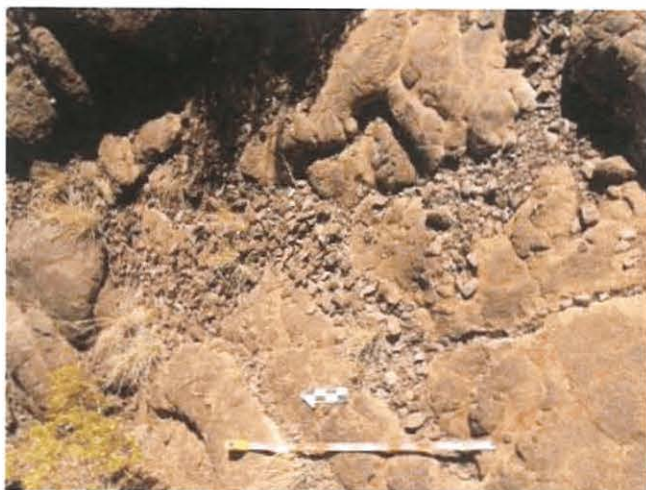
Plate 15. Site 21671 Feature 12 photo to the north-northwest. Extraction area with lithics on northeast side of site.

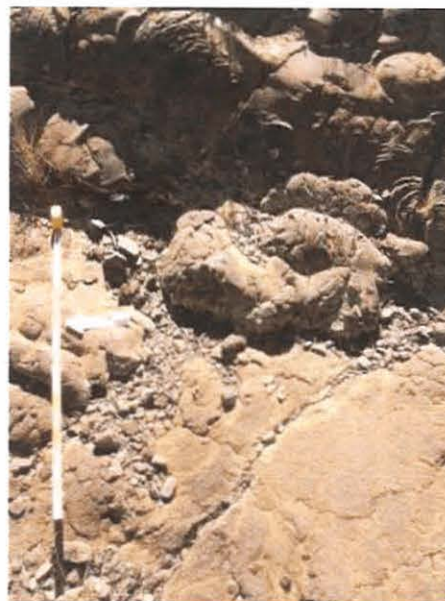
Plate 16. Site 21671 Feature 12 photo to the southeast. Extraction area and lithics on the east side of the feature.

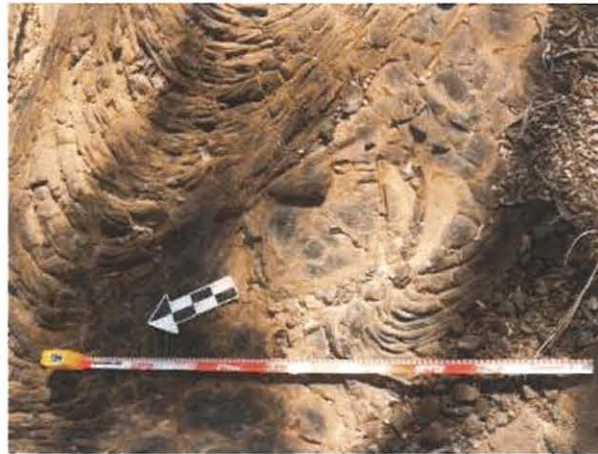
Plate 18. Site 21671 Feature 12 Large piece of shrapnel on north side of feature

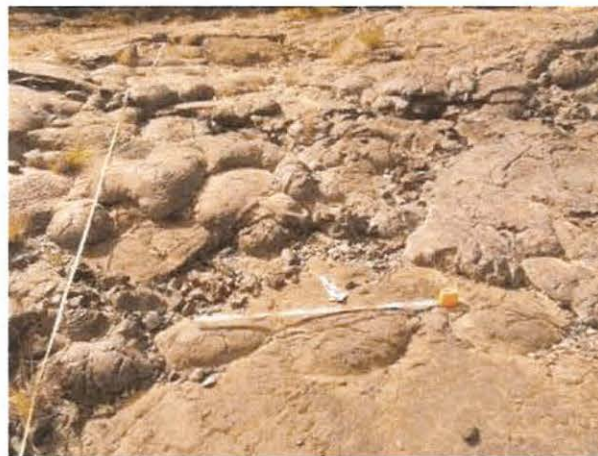
Feature 11 measured 27 m at 0° by 14.5 m at 90°. The pāhoehoe at this feature was very glassy, and in many places it was observed overlying and adjacent to duller pāhoehoe. At about 26 m north of the mapping datum the pāhoehoe was ropy, though still glassy. The GANDA site tag was relocated. Some pieces with flake characteristics were noted, but there were also a number that appeared to have resulted from natural weathering processes. Loose pieces of rock were found that remained in place, but when lifted out bore characteristics of a feather termination. These pieces, though clearly natural, could easily be mistaken for the distal fragment of a broken flake. A piece of PVC pipe was set into a crack close to 27 m north of the datum established for mapping during this monitoring event, and a metal bar on the

Plate 20. Site 21671 Feature 11 Extraction location and artifacts, interface of glassy and dull lava, photo toward the south.

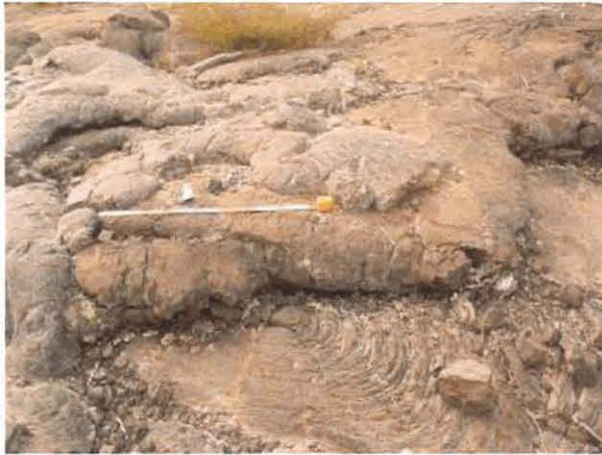
Plate 21. Site 21671 Feature 11 photo to the south. Extraction area with artifacts, flow interface. Possible ammunition impact area on the right of the photo.

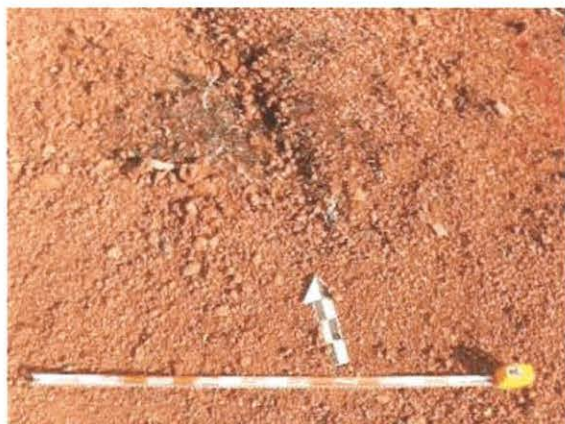
Plate 25. T-092202 vicinity, possible lithic scatter

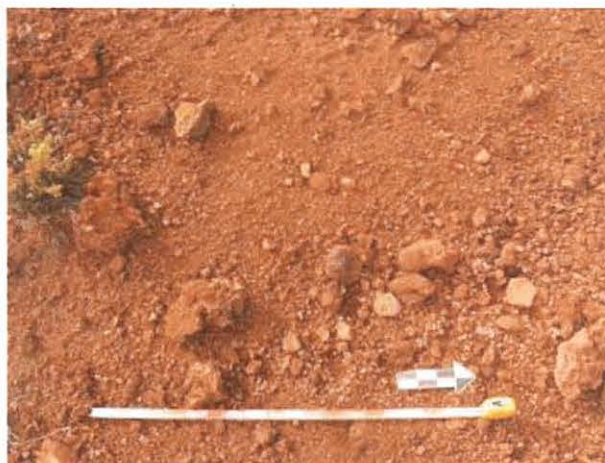
Plate 26. Site T-092202 area Second lithic scatter, to southeast of previous photo. Photo toward the southwest.

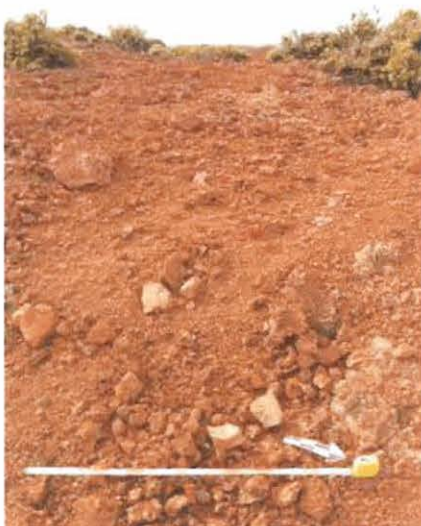
Plate 27. Site T-092202 vicinity. Possible lithic scatter 2.

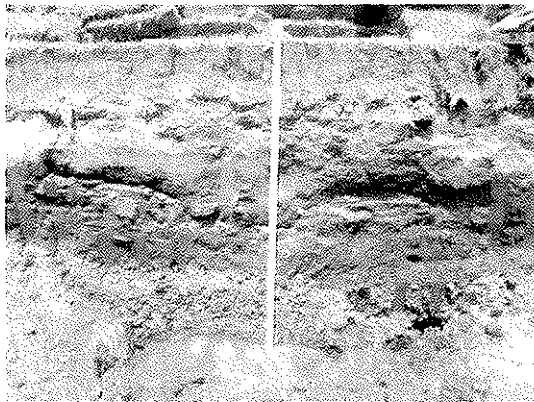
**Findings** – A small void, measuring 2.4m across (90/270 °) by 0.40m high by 1.8m deep was found in the northwest corner of the Septic Tank #01 excavation. An examination disclosed no archaeological material in the small closed space. Photographs were taken (Plate 64) and excavation continued. Seven natural levels were recorded in a stratigraphic profile of west wall of S.T. #01 (IWS #01 – Profile #01, Plate 65).

Plate 65. IWS #01 – Profile #01 looking to 260° (west). The scale is ca. 1.2m long.

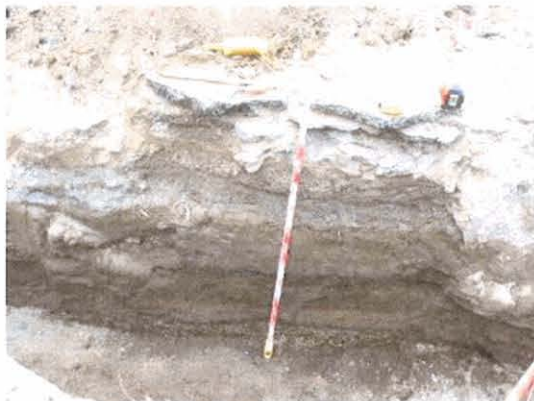
**Findings** – Excavation of Cesspool #02 disclosed five small pieces of rusted corrugated roofing material and three rotted logs. These appeared to be associated with an earlier temporary roof of the cesspool and did not appear to be in context. Monitoring of IWS #02 produced no other cultural material. Nine natural stratigraphic layers were recorded in a sample stratigraphic profile of the southeast wall of Septic Tank #02 (IWS #02 – Profile #01, Plate 67).

Plate 67. IWS #02 – Profile #01 to 280° (west). The horizontal scale is 1.0m, the vertical is ca. 1.4m.

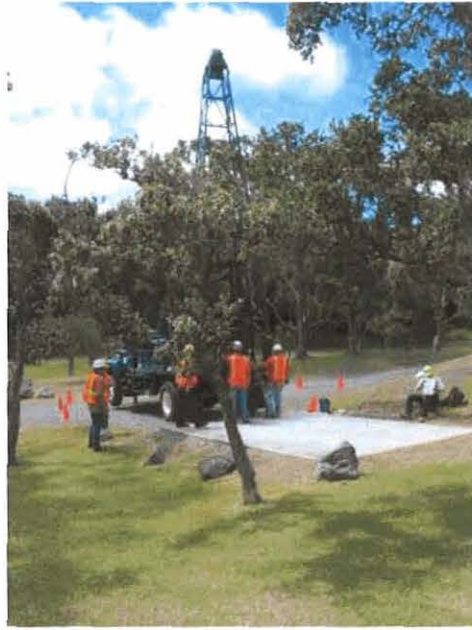
**Activities Monitored** – Prior to the beginning of construction at IWS #04, a truck-mounted drill rig operated by Leslie Drilling dug test holes (Plate 68). The drilling was to determine buried stratigraphy and to test for the presence of voids. These test holes were approximately 4" (0.10m) in diameter. Monitoring of the drill cuttings found no cultural materials.

Plate 68. A view of the Leslie Drilling rig during operations at IWS #04.

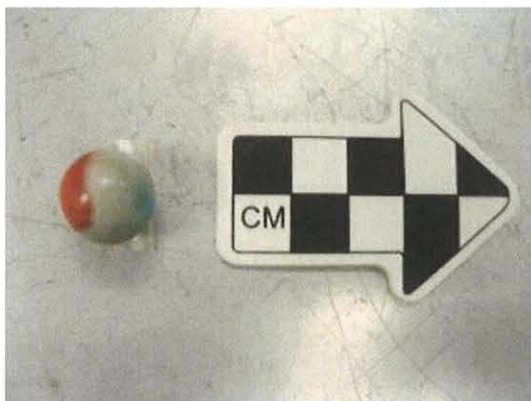
A single orange, blue and white glass marble (Plate 70) was found in the back-dirt pile from the trench excavation between SMH #04 and Septic Tank #04. It appears to have come from near the northeast corner of Bldg. #97, but this is uncertain. Further discussion of this artifact is given in the Findings section.

Plate 70. The small marble found during monitoring of IWS #04.

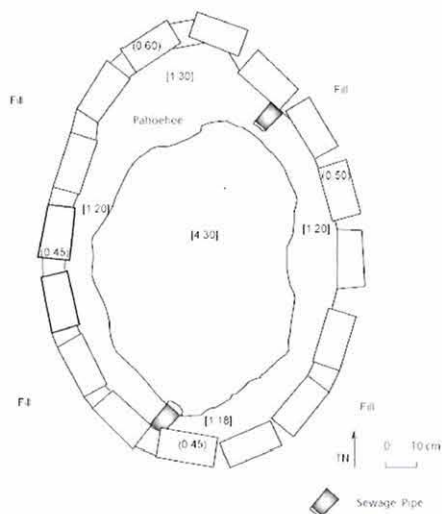
**Findings** – Removal of the cover of existing Cesspool #04 on July 23, 2007, disclosed a rough semi-circular wall of joined cinder blocks resting atop the pāhoehoe surrounding the cesspool. A poured concrete collar set on top of the pāhoehoe, topped by stacked alternating rectangular cement blocks. Sections of rebar tied these blocks together and concrete filled in the holes of the blocks. IWS #04 – Feature #01 served to support the concrete and rebar cover on top of Cesspool #04. The feature was designated IWS #04 – Feature #01 and measured approximately 1.5m (N/S) by 1.0m (E/W) by 0.70m high. The feature was described, photographed (Plate 69), and both a plan and profile drawing were completed (Figures 40 & 41).

Figure 40. IWS #04 – Feature #01 plan view.

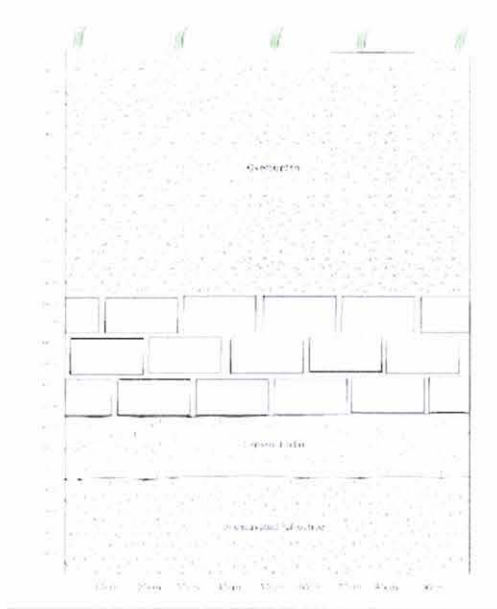
Figure 41. An idealized profile view of Feature #01. The feature was not entered due to safety concerns.

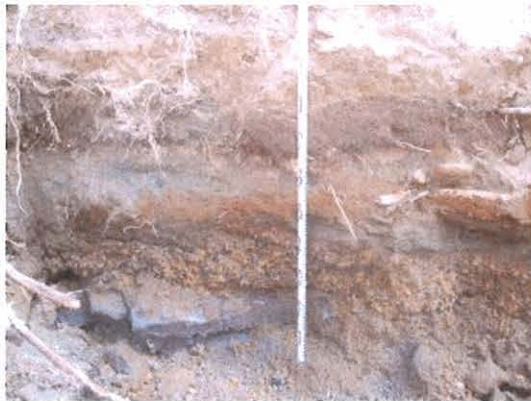
Two soil profiles (IWS #04 – Profiles #01 and #03) were recorded in the sides of the excavations. Profile #01 was in the northeast corner of the HAP #04 excavation (Plate 71) and #02 was located in the trench near SMH #04 near the eastern end of the IWS (Plate 72).

Plate 71. IWS #04 – Profile #01 looking to 330° (northeast) in the Absorption Bed. The scale is truncated, but is ca. 1.0m long.

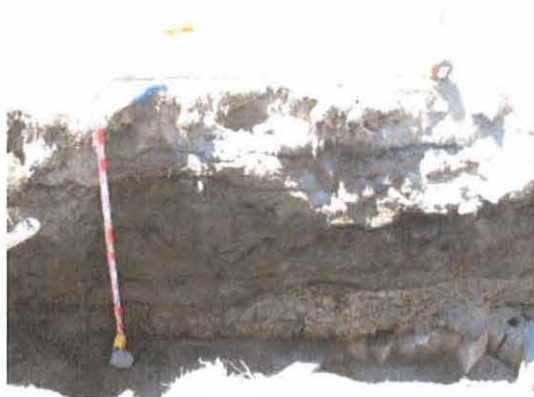
Plate 72. IWS #04 – Profile #02 looking to 155° (south\southeast). The scale is ca. 1.3m long.

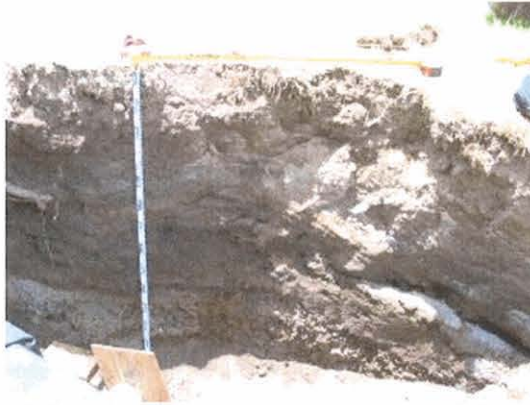
Two soil profiles (IWS #06 – Profiles #01 and #02) were recorded of the sidewalls of the excavations. Profile #01 was in the south corner of the Septic Tank #06 excavation (Plate 73) and #02 was located in the trench between Septic Tank #06 and the new VAP #06 near the eastern side of the IWS (Plate 74).

Plate 73. IWS #06 – Profile #01 to 180°. The horizontal scale is 1m and the vertical is ca. 1.3m long.

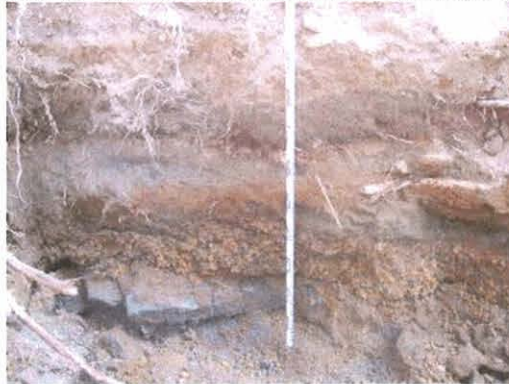
Plate 74. IWS #06 – Profile #02 looking to 180° (south). The vertical scale is ca. 1.5m long.

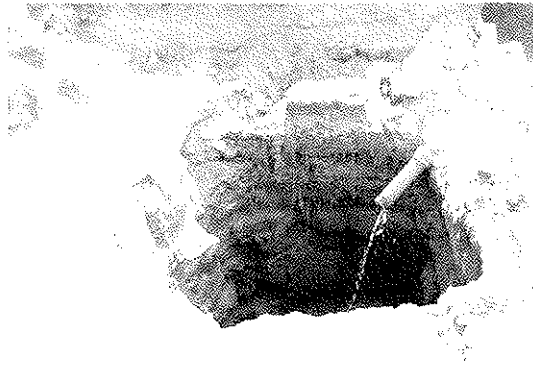
After this determination was complete, James Head took photographs (Plate 75) and drew a plan and profile of the cesspool (Figures 42 & 43). After all recording was completed, and construction work resumed at Cesspool #07 on July 23, 2007.

Plate 75. Cesspool #07 after removal of the cement/rebar cover. The view is to 90°, the scale is 1.0m.

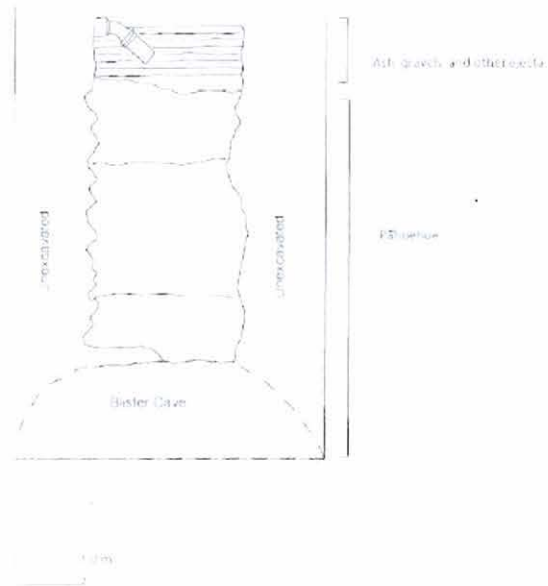
Figure 43. An idealized profile view of the walls and floor of Cesspool #07. Entry into the feature was not allowed due to safety concerns.

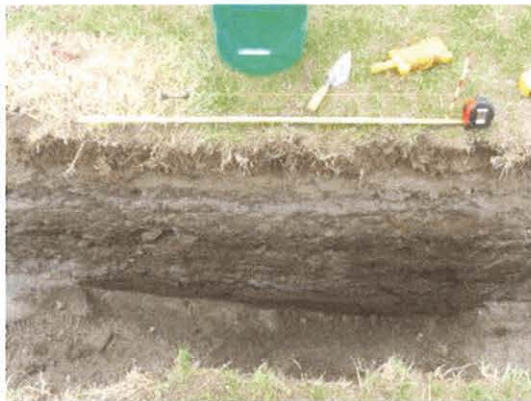
A soil profile (IWS #07 – Profile #01) was recorded in the north wall of the trench running from Septic Tank #07 to VAP #07 (Plate 76).

Plate 76. IWS #07 – Profile #01 looking to 180° (south). The scale is 1.0m long.

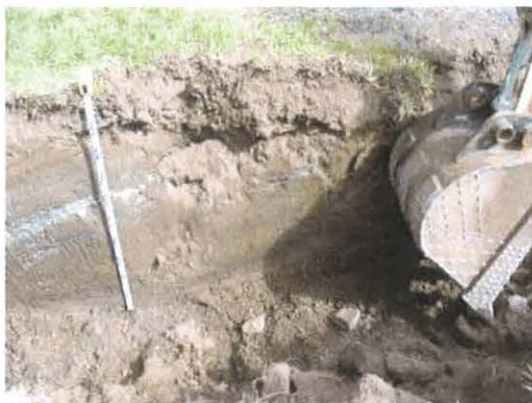
**Findings** – The monitor located no prehistoric or historic items or features during the construction activities at IWS #10A. One soil profile (IWS #10A – Profile #01) was done in the long trench near Lint Interceptor #10A (Plate 78).

Plate 78. IWS#10A – Profile #01 looking to 160° (south\southeast). The scale is 1.0m long.

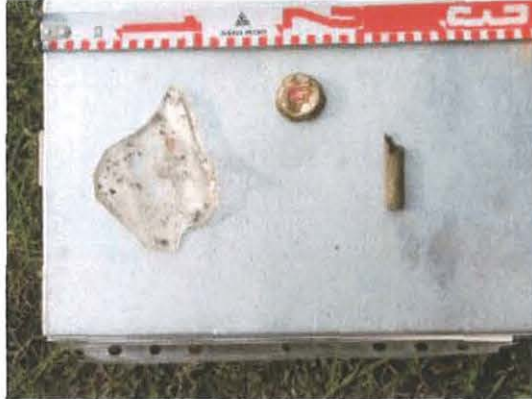
**Findings** –Testing for existing pipes at IWS #11 located Concentration #01 during hand excavation. Concentration #01 was located just to the west of Bldg. #30. A grouping of three artifacts was found in an area approximately 0.30m<sup>2</sup>. The concentration included a partial military rifle cartridge, one piece of clear bottle glass, and an aluminum twist-off Schlitz Beer cap (Plate 79). Further discussion is given in the Artifacts section. Reburial of the artifacts took place after photography and description were

Plate 79. The three items found in IWS #11 – Concentration #01.

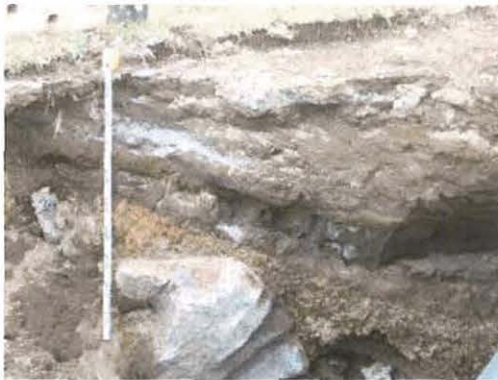
Plate 80. IWS #11 – Profile #01 looking to 260° (west). The vertical scale is 1.0m long.

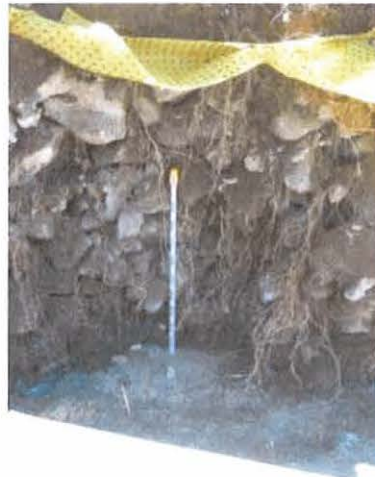
**Findings** – Two features, both of which appear to be historic, were located during the monitoring of IWS #12a. IWS #12 – Feature #01 (Plate 81) was a rock-filled pit located in the southeast corner of the Septic Tank #12a excavation. The pit measured approximately 2.4m wide by 1.5m deep and was filled with soil and many small basalt rocks, many of which still had concrete adhering to the surfaces. The pit was covered with soil and was resting below the sidewalk. A test unit (1m<sup>2</sup> by 0.44m deep) was placed to the south of the sidewalk to determine the extent to the south, but the results were not conclusive. The southeast wall of the pit appeared to be approximately 0.50m from the exposed face of the excavation. The feature appears to be a trash pit from a former cement-rock feature and did not appear to contain any cultural material other than the concrete-covered rocks (Figure 44).

Plate 81. IWS #12 – Feature #01 looking to 210° (south\southwest). The scale is 1.0m.

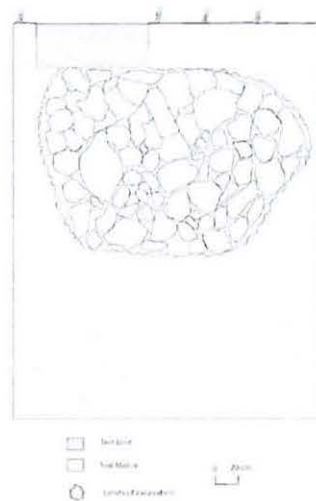
Figure 44. Profile of Feature #01.

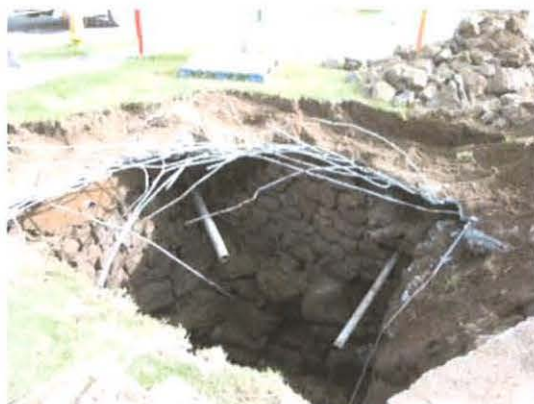
IWS #12 – Feature #02 was a square enclosure of dry-laid basalt masonry used to support a concrete and rebar cover at Cesspool #12 (Plate 82, Figure 45). It was built of pāhoehoe cobbles and small boulders stacked seven to nine rough courses high resting on pāhoehoe. This feature measured about 3.1m (N/S) by 2.5m (E/W) by 1.9m high. The eastern wall was capped with a concrete cap that

supported a rusted sewer inlet line. On the south, the wall was about the same height, but the western wall had collapsed into the cesspool. The northern wall was gone except for a single stack of rocks near the eastern wall. The structure was photographed and recorded when it was exposed.

Plate 82. IWS #12 – Feature #02 after the cover removal. View to 210° with a 1.0m scale.

IWS #12 – Feature #02 appears to have functioned as support for the concrete\ rebar cover that rested atop the structure. The feature also provided support for the incoming septic lines that emptied into the old cesspool. It is believed that the concrete and rebar cover was a later addition, and the original was simply wooden supports topped with corrugated roofing material. After consultation with the USAG-HI Cultural Resources Manager, it was decided to attempt to place the new inlet pipe and preserve the structure, but the feature collapsed into the cesspool before this could be carried out.

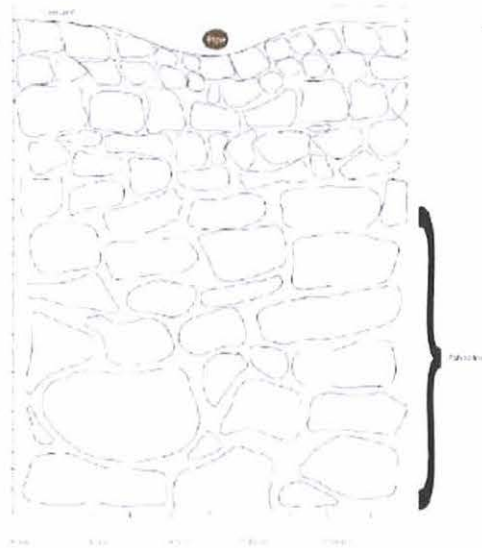
Figure 45. Profile of the east wall of IWS #12 – Feature #02.

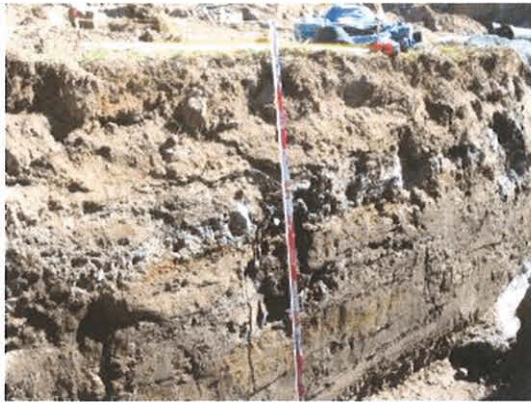
One soil profile (IWS #12 – Profile #01) (Plate 84) was done in the long north/south trench excavation located west of VAP #12.

Plate 84. IWS #12 – Profile #01 to 130°. Horizontal scale is 1.50m, the truncated vertical scale is 1.2m.

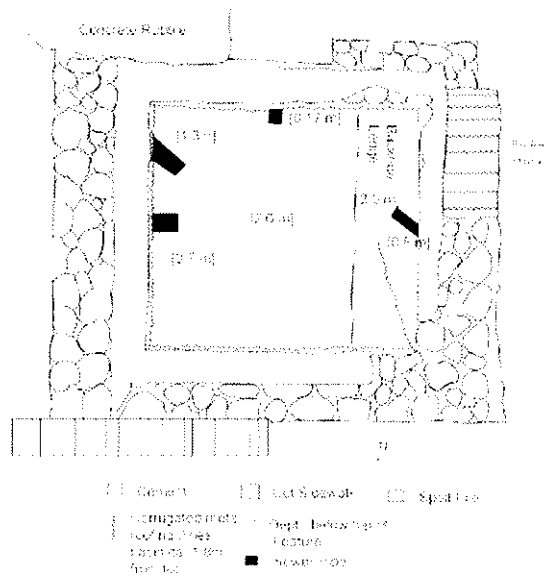
Figure 46. Plan view of IWS #13 – Feature #01.

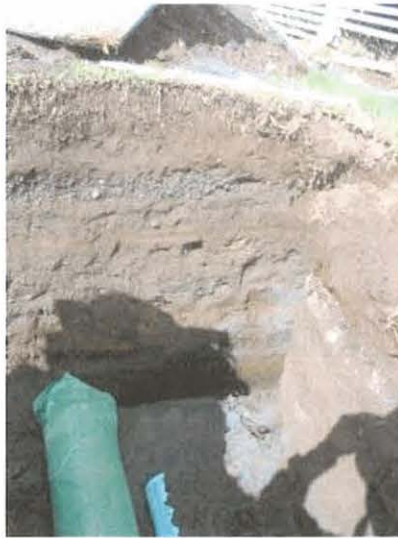
Plate 86. IWS #13 – Profile #01 looking to 270° (west). The scale is 1.0m long.

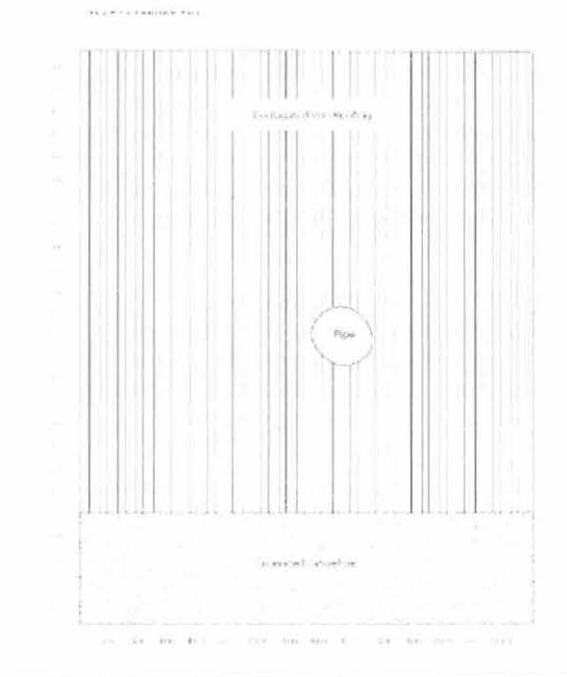
Figure 47. Idealized plan view of the south wall of IWS #13 – Feature #01. The feature was not entered due to safety concerns.

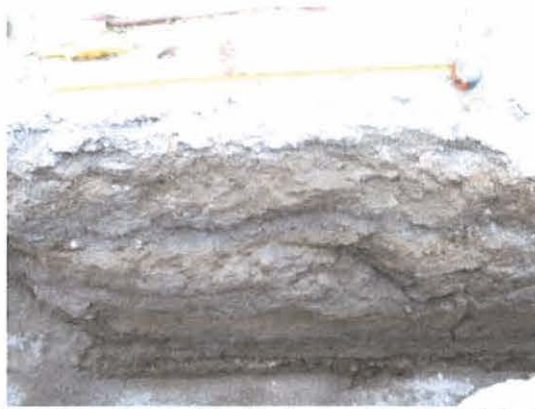
The missing Cesspool #15 was also found lying under an existing road during the IWS #14 excavations on September 14, 2008. Although the Cesspool was only partially exposed, it appeared to be a cement tank with cement and rebar cover measuring ca. 10 (N/S) x 12 x 3-4m high. It was avoided by the construction, was pumped, isolated from the new system, and back-filled. One soil profile (IWS #14 – Profile #01) (Plate 89) was recorded in the trench excavation located to the west of Bldg. #28.

Plate 89. IWS #14 – Profile #01 looking to 90°. The horizontal scale is 1.0m long.

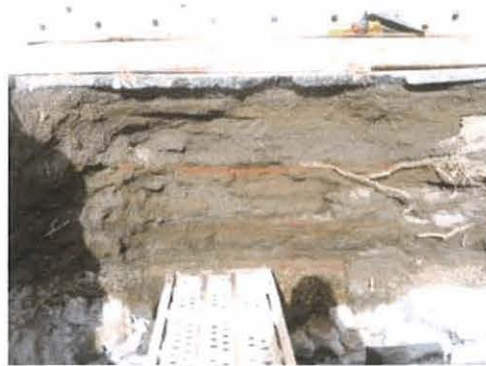
One soil profile (IWS #17 – Profile #01) was recorded in the Septic Tank #17 excavation located northwest of Bldg. #74 (Plate 28).

Plate 91. IWS #17 – Profile #01 looking to 90° (east).  
The scale resting on the pavement is 1.0m long.

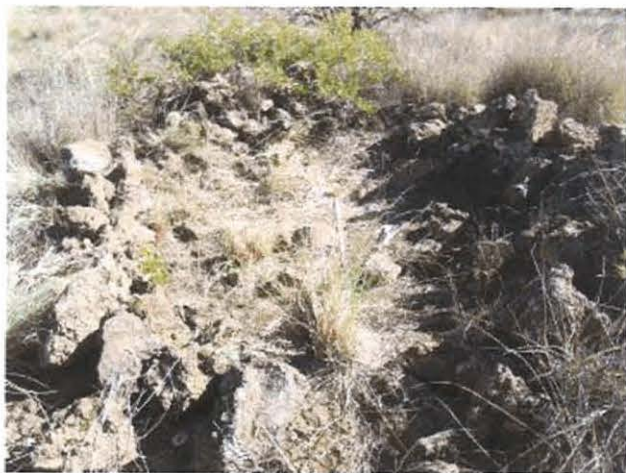
Plate 132. T-090607-01 Military fortification

28. MT-090607-01 is an enclosure on a ridge to the south of Firing Point 505 (Plate 132). It is an irregular ring of rocks stacked in a haphazard manner. The rocks do have lichen, but it is not consistently on the same side, indicating that they have been stacked relatively recently. Bullet casings and links for ammunition were found nearby. The feature measured 3.2m by 3.9m. The width of the rock perimeter wall was highly variable. The long axis (north-south) is perpendicular to the trend of the ridge line. The center appears to be somewhat depressed below the level of the surrounding ground surface.

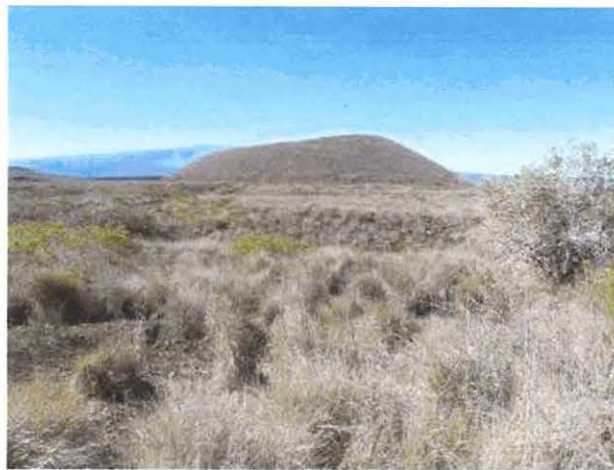
Plate 133. Photo of Survey area north of Pu'u Ka Pele, looking southeast toward Pu'u Ka Pele.

29. From this location south to Pu'u Kapele the landscape is more rolling, possibly the result of collapsed lava tubes with higher ridges and linear low areas between the ridge lines (Plate 133).

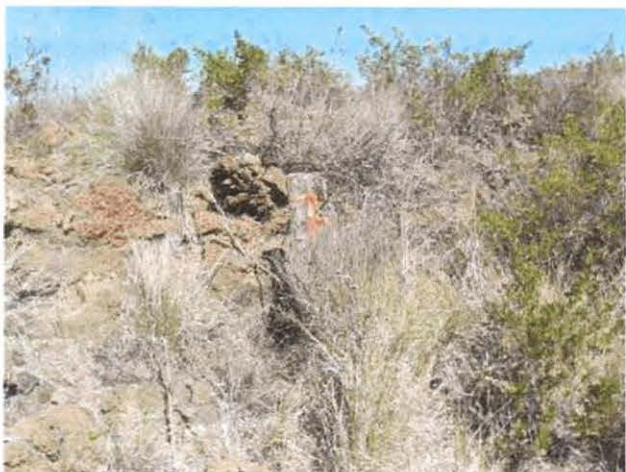
Plate 134. Site 23452 Fence Post

30. A fence post of site 23452 was located at the western edge of the survey transect (Plate 134). The fence post was flagged with orange flagging tape so that it is obvious to the fence crew and can be avoided. Barbed wire was present on the ground surface near the post. The barbed wire continues without posts to within about 10m of the road. The area between the historic fence line and the road shows evidence of extensive bulldozing.

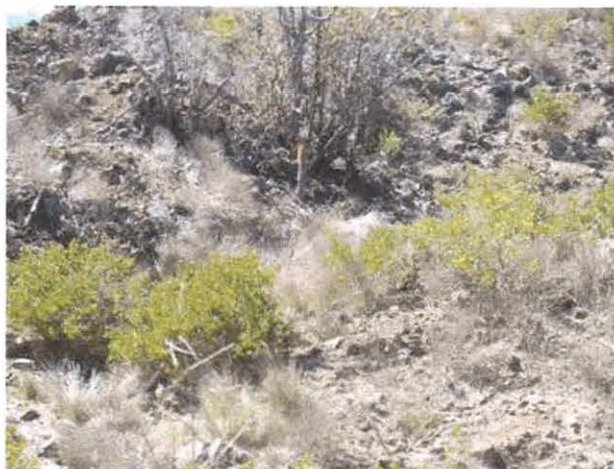
31. Closer to the road, two more fence posts were identified, along with additional barbed wire. The southernmost fence post on the western side of Kīpuka Road appears to have been a tree that was cut off and used as a fence post; it stands within a copse of trees (Plate 135). Both of these fence posts were also flagged with orange flagging tape and labeled with the site number so that the fence crew can be certain of avoiding the posts. Barbed wire was located to the southeast of the fence post in the copse of trees. A GPS point was collected on the southernmost end of the

Plate 135. Site 23452 Fence Post.  
New fence line is to run just to the left of the photo

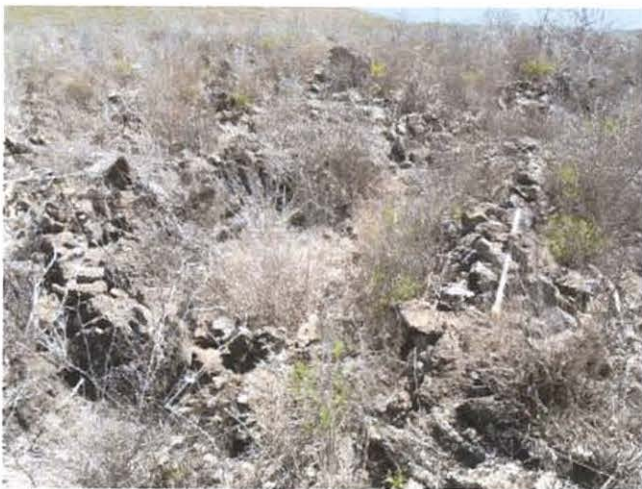
Plate 136. Western T-090607-02 Room

34. On the south side of the ridge, and area with extensive rock construction was identified as T-090607-02. Communications wire, cans (possibly from C-rations), plastic plates, cardboard, foil, and bullet casings were all present in this area. At least two rectangular rooms were present along the southern edge of the ridge line (Plates 136 and 137). The front (southern) wall continues to the west (Plate 138), and ends in a rounded construction that has the appearance of a C-shaped structure (Plate 139), probably of military construction. Two more C-shaped structures, probably of military construction, were located west of this. Some construction appears along two natural ridges of lava, probably adding rocks to them, that run perpendicular to the southern wall along the ridge line (Plate 140). The walls generally stand about 0.5m above the ground surface. This site was minimally recorded. The crew then progressed to a fence post that was visible to the east on the south side of the ridge.

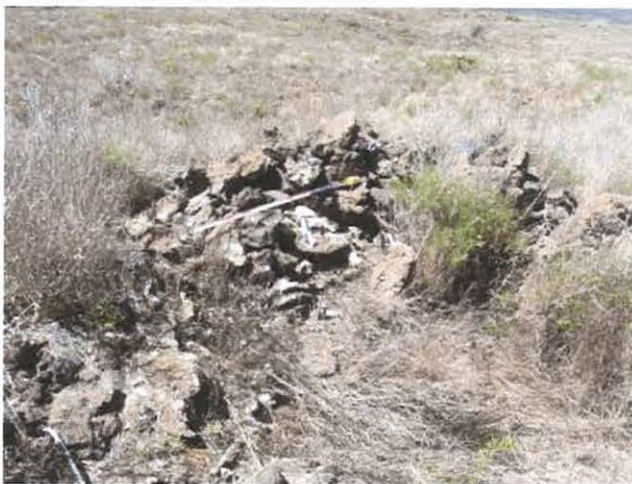
Plate 139. C shape toward western end of T-090607-02

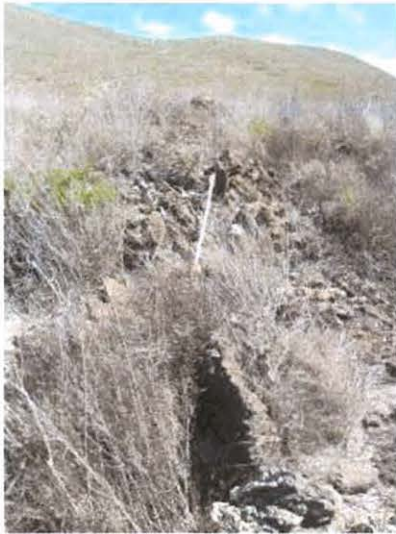
Plate 140. Modified outcrop on northern side of T-090607-02

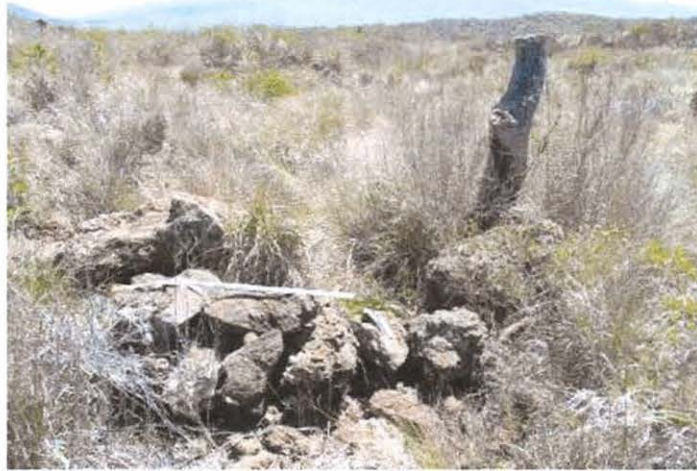
35. This post had both barbed wire and heavy gauge wire wrapped around it. A linear pile of rocks about two courses high extended on the western side of the post to the north (Plate 141). The rock pile was about 1.5m long (north-south) by 0.5m wide. Large boulders were located on the east side of this pile at the northern and southern ends. The southern boulder was between the fence post and the linear pile.

Plate 141. Site 23452 Fence post with associated linear mound

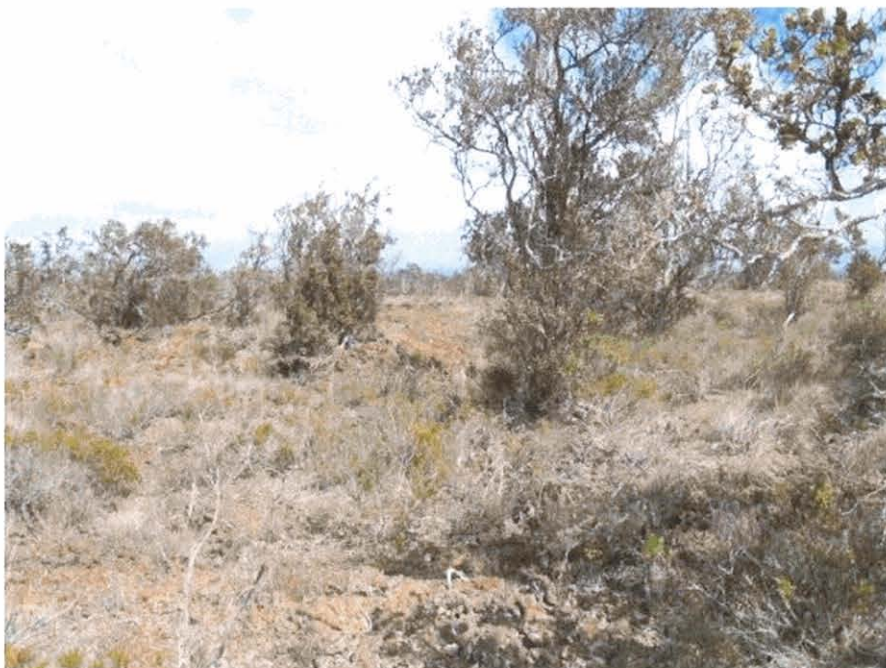
Plate 142. Overview of June 2006 sites area

6. From here, the group continued to the end of the fire access road priority 1 (Figure 142). We parked the trucks in a pull-out and walked across the lava to the location where the fence crew had encountered this cluster of sites (Figure 63, Plate 142). This cluster of sites was recorded on June 28 and June 29, 2006, and given temporary site numbers corresponding to those dates. They are reported in Escott 2007. The sites include a lava tube shelter and surface structures. The two temp sites closest to the proposed fence line were T-062806-05 and T-062806-01. The cultural resource specialists discussed the proposed fence route with the fence crew, and determined a route that will avoid the features in this area.

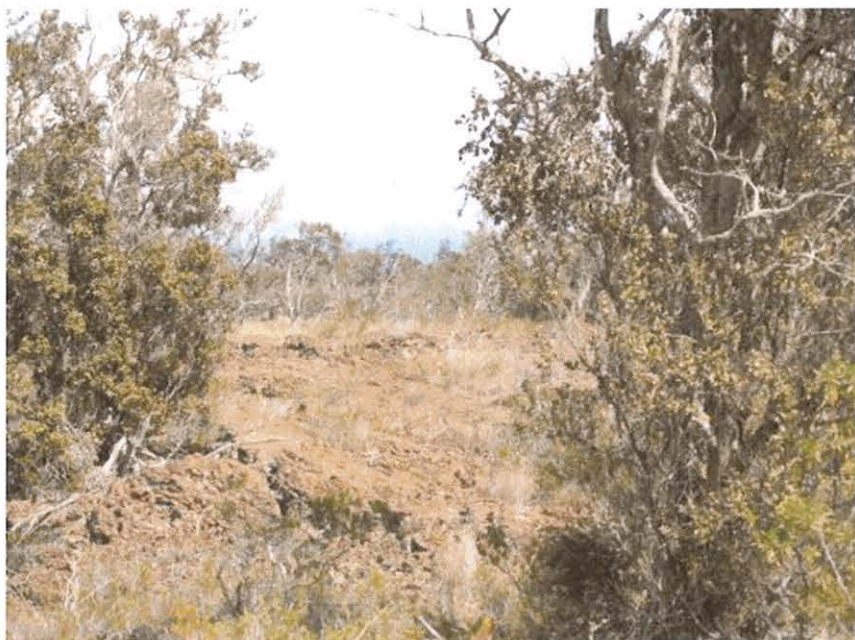
Plate 143. View of Proposed Fence Line Route

7. The fence project is avoiding historic properties identified along the proposed on the western side of the Pohakuloa Training Area (Plate 143). We recommend that monitoring and the close working relationship with the fencing program continue to ensure continued avoidance of historic properties.
